ELLIS DAM
CT 00478

PHASE I INSPECTION REPORT NATIONAL DAM INSPECTION REPORT

Identification No:	CT 00478
Name of Dam:	Ellis Dam
Town:	Stafford
County and State:	Tolland, CT
Stream:	Ellis Brook
Date of Inspection:	29 December, 1980

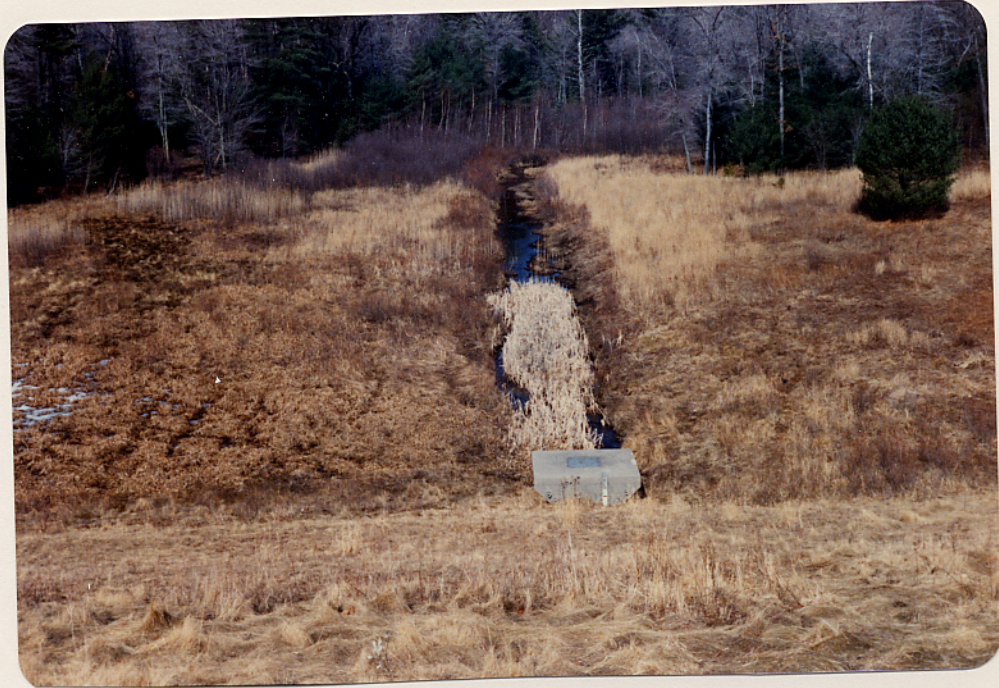
C-3 UPSTREAM APPROACH CHANNEL

- d. Reservoir Area. Except for the area in the immediate vicinity of the dam, the reservoir area is heavily wooded as shown in the overview photo and Photo No. C-3. The flood area is generally about 1,200 feet west of Kemp Road and is not near any roads or homes. No detrimental features in the reservoir area were observed.
- e. Downstream Channel. The downstream channel for Ellis Dam is a natural stream called Ellis Brook as shown in Photo No. C-3. About 500 feet downstream, Ellis Brook crosses Tetrault Road. About 4,000 feet downstream, the brook enters the grounds of a private swim club and recreation area. It appears that camp trailers are parked in the area during the summer season.

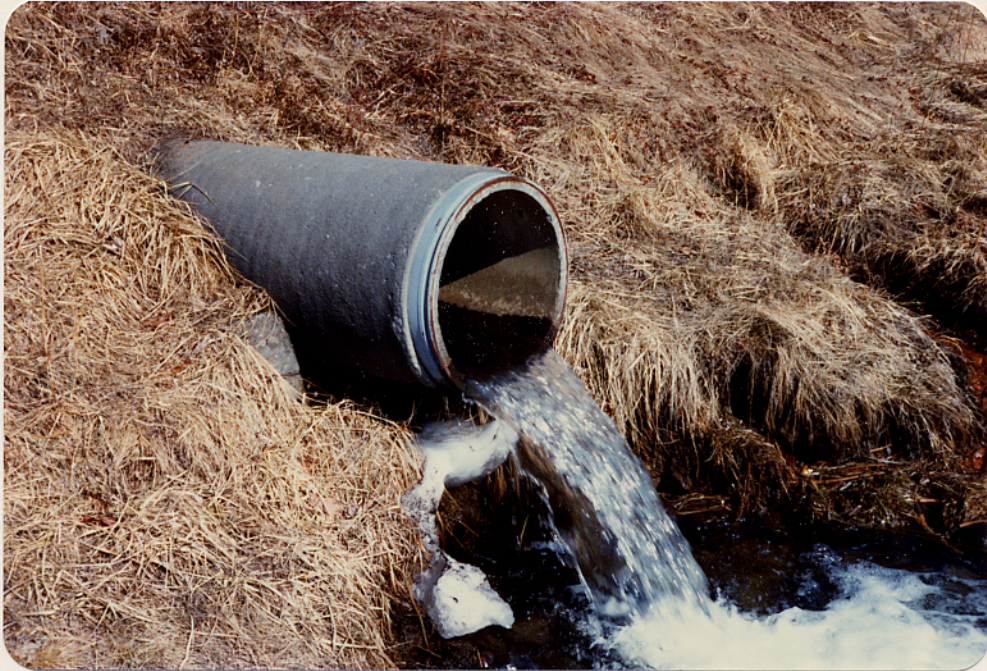
C-7 PRINCIPAL SPILLWAY OUTLET

There is a 24-inch concrete pipe from the riser through the embankment to the outlet. The portion of the pipe that is visible is in good condition and is shown in Photo No. C-7. The last pipe at the outlet is 16 feet in length and is supported at mid-point by a reinforced concrete bent 8 feet deep. The remainder of the outlet pipe is supported on a reinforced concrete collar. The outlet from the principal spillway is in good condition with no apparent erosion in the channel. Plans show five antiseep collars on 23 foot centers from the upstream face of dike to just beyond the centerline of dam. Collars are 7.5 feet high and 11.3 feet wide. A bent and cradle are not visible, but there are no outward signs of any problems.

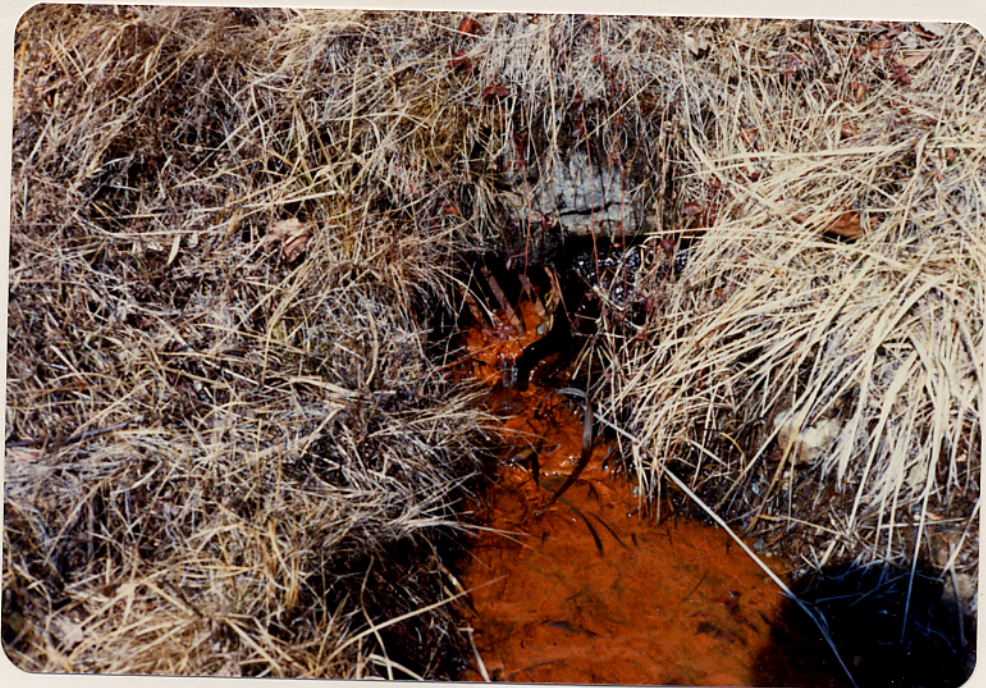
C-8 FOUNDATION DRAIN OUTLET

Foundation drains appear to be functioning with minor flow at the time of the inspection. An outlet to a foundation drain is shown in Photo No. C-8. The estimated flow from each of two drains at the time of the inspection is 4 gallons per minute.

1. Fill holes in the spoil area and monitor for reoccurrence.
2. Emergency procedures consisting of an operation plan and warning system for downstream residents should be developed and implemented.
3. Maintain a record of maximum water levels during flood events for future evaluation studies.
4. During flood events, check dam for evidence of seepage.
5. Institute a biennial inspection of the dam by technical personnel.
6. Place riprap at outlet of principal spillway.
7. Monitor seepage from foundation drains during future technical inspections.

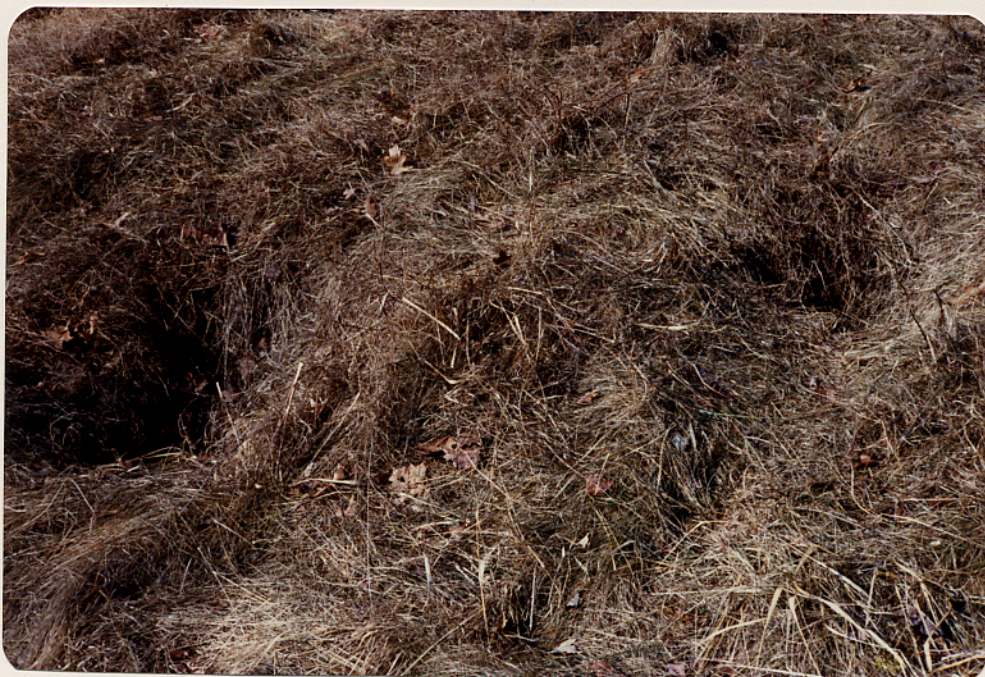
C-10 SETTLEMENT AREA DOWNSTREAM SLOPE

AREA EVALUATED	CONDITION
<u>SPOIL AREA</u>	
Location	Downstream slope of dike embankment west of emergency spillway on original ground.
Condition	Several sink holes as would occur over nested boulders or clearing debris.

- a. Fill depressions in the apparent spoil area as shown in Photos C-10 and C-11. Although the depressions have no effect on the stability or function of the dam, they present a hazard to anyone walking in the area.

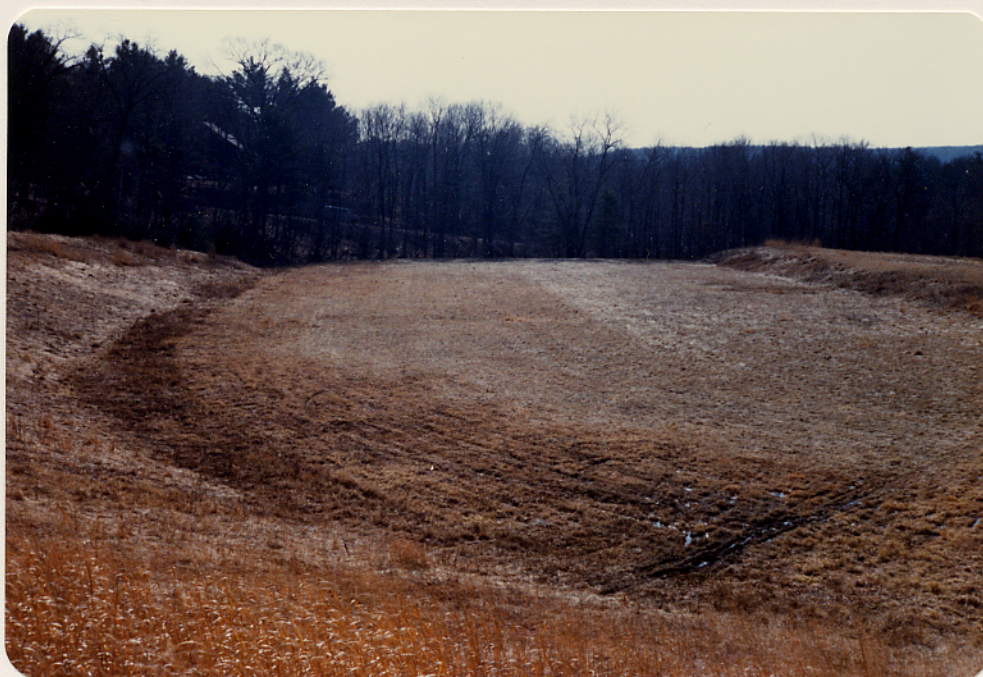
C-12 EMERGENCY SPILLWAY

2. Emergency Spillway - The emergency spillway is grass lined with a 150 foot bottom width and is shown in Photo No. C-12. There is a good mat of grass and the spillway is in good condition.
